| Document ID | AS-337669 |

| Vehicle Brand | Mini Cooper |
| Model | Countryman |
| Year | 2017 |

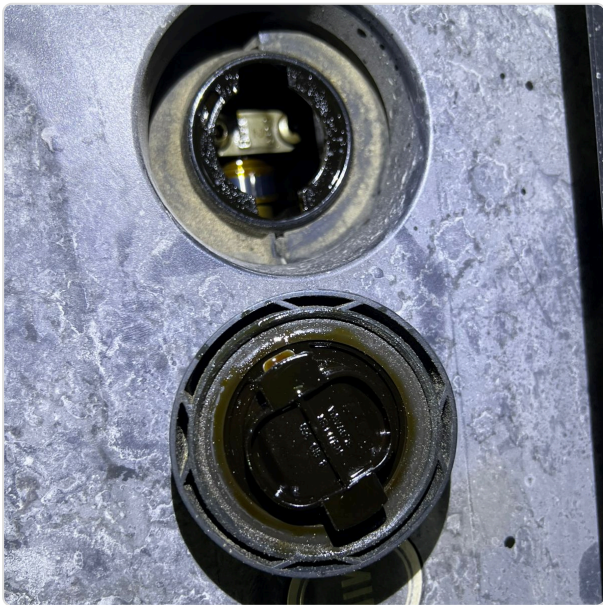
| Engine Oil Photo | |

| Engine Oil Level | Oil is black need to be replace |

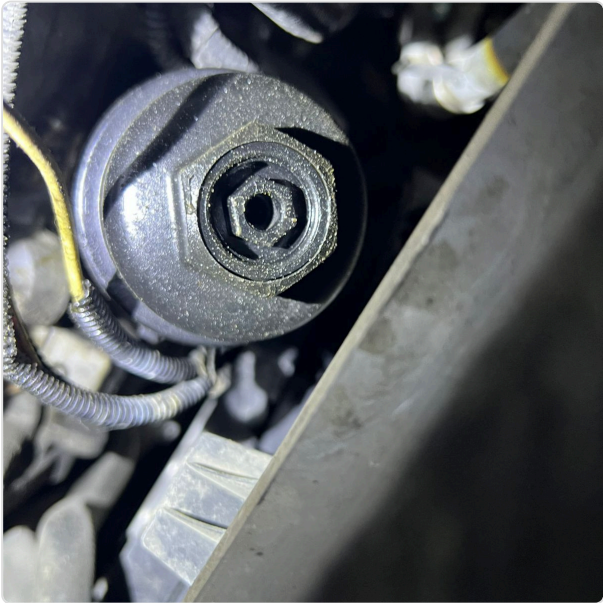
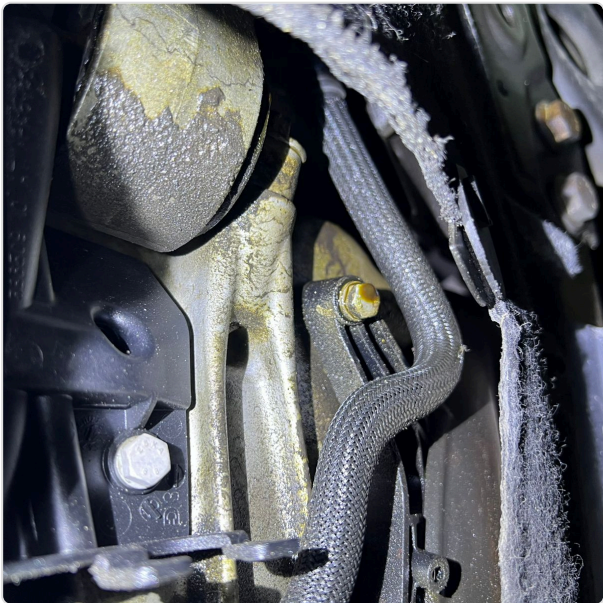
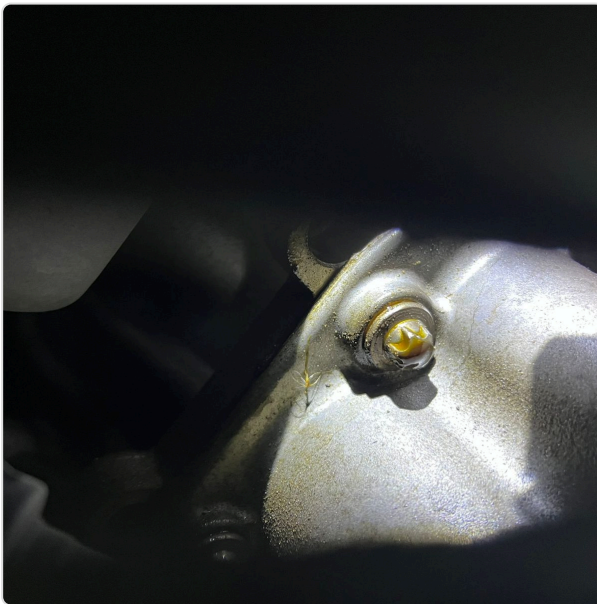
Oil Leaking Photo

Oil leaking from timing cover and crankcase gasket

Engine oil leaking from timing cover and crankcase gasket. All the shock absorber needs to be replaced. All the tyre needs to be replaced. Rear brake pads needs to be replaced. Minor scratches on body.

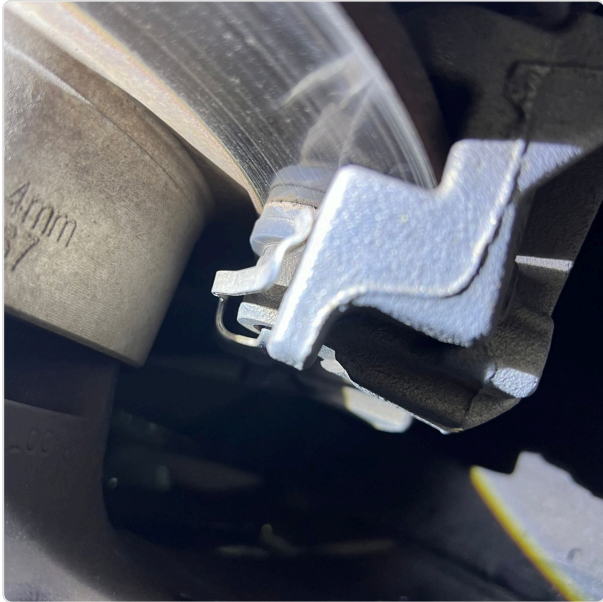
| <p>Rear Braks Pads Photo</p> | |

| <p>Braks Pads Rear</p> | <p>Need to be replaced</p> |

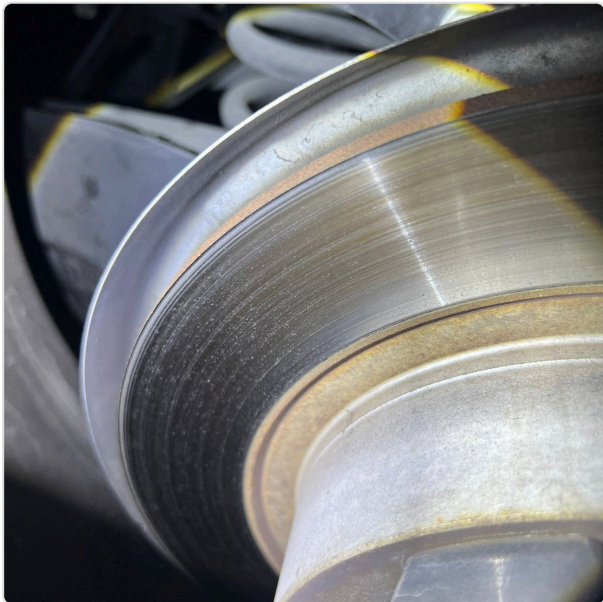
| <p>Rear Braks Discs Photo</p> | |

| <p>Braks Discs Rear</p> | <p>Needs to be make skimming</p> |

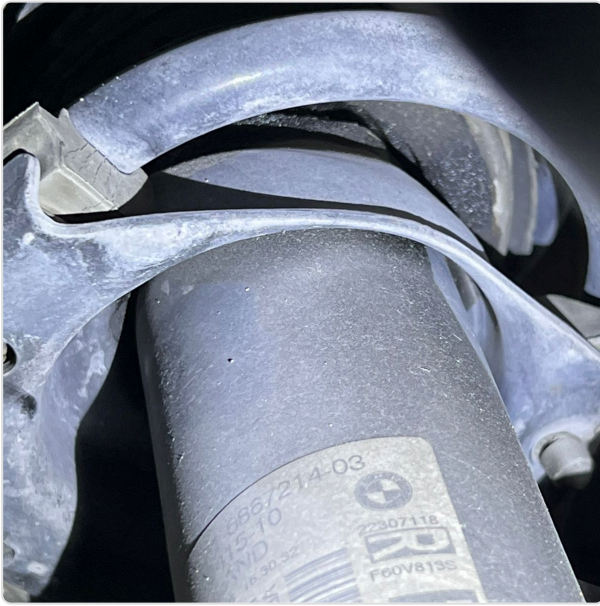
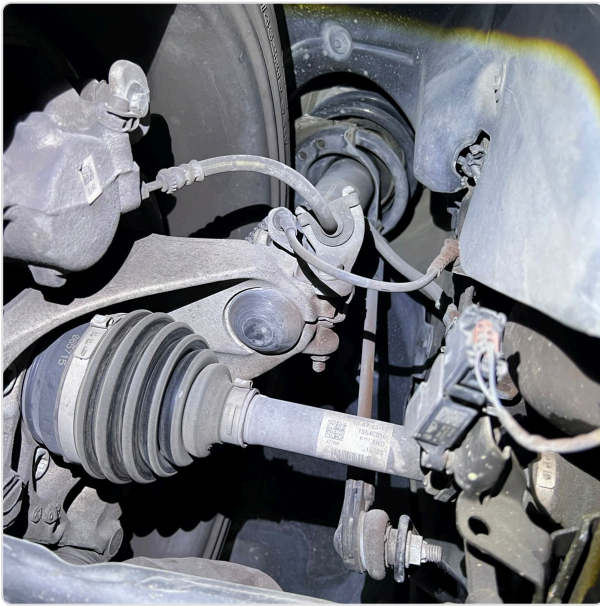
| <p>Front Suspension Photo</p> | |

| <p>Front Suspension</p> | <p>Both sides shock absorber needs to be replaced.</p> |

| Is suspension smooth (no abnormal noises)? | Noise because of shock absorber. |

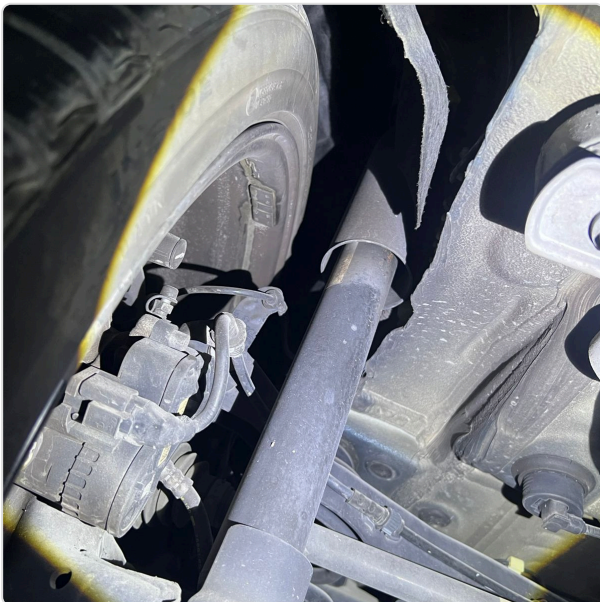
Rear Suspension Photo

Rear Suspension

Other

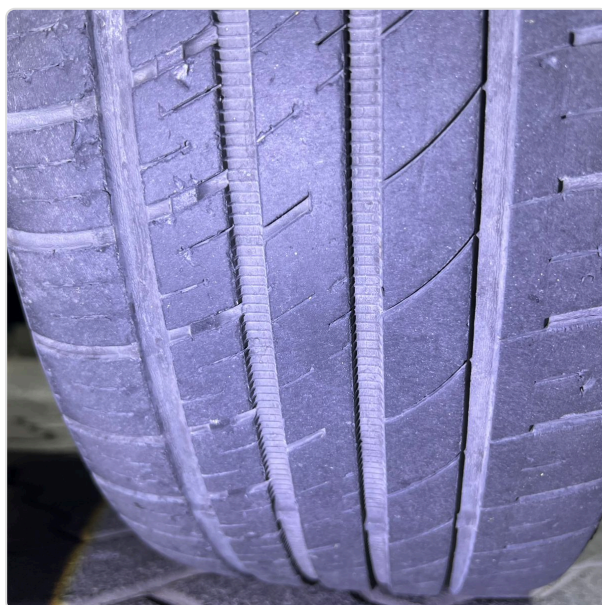
Front Right Tyre Photo

| Position | Manufacturer | Date | Size | Condition |
|---|---|---|---|---|
| Front Right Tyre | Nexen | 2022 | 225/45ZR19 | Needs Replace |

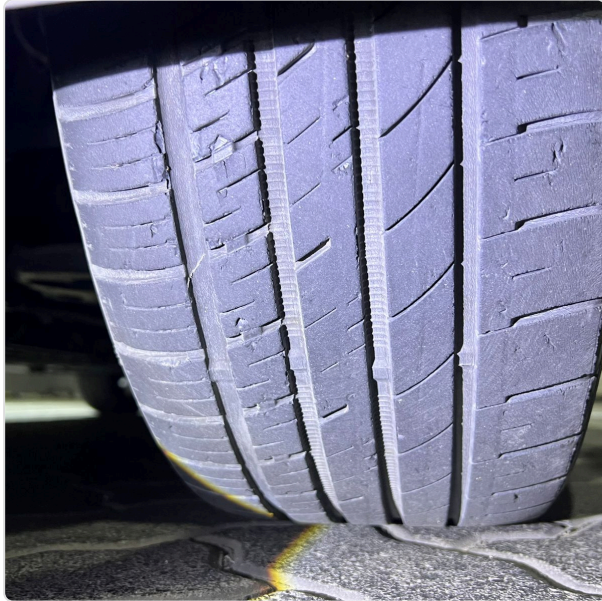
Front Left Tyre Photo

| Position | Manufacturer | Date | Size | Condition |
|---|---|---|---|---|
| Front Left Tyre | Nexen | 2022 | 225/45ZR19 | Needs Replace |

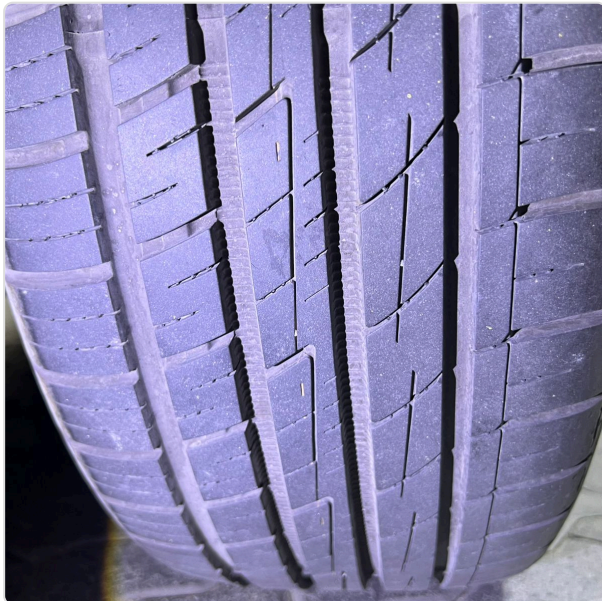
Rear Right Tyre Photo

| Position | Manufacturer | Date | Size | Condition |
|---|---|---|---|---|
| Rear Right Tyre | Nexen | 2022 | 225/45ZR19 | Needs Replace |

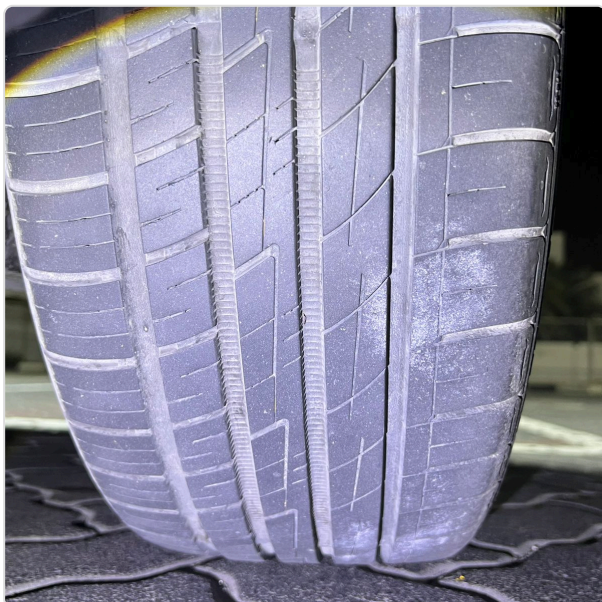
Rear Left Tyre Photo

| Position | Manufacturer | Date | Size | Condition |
|---|---|---|---|---|
| Rear Left Tyre | Nexen | 2022 | 225/45ZR19 | Needs Replace |

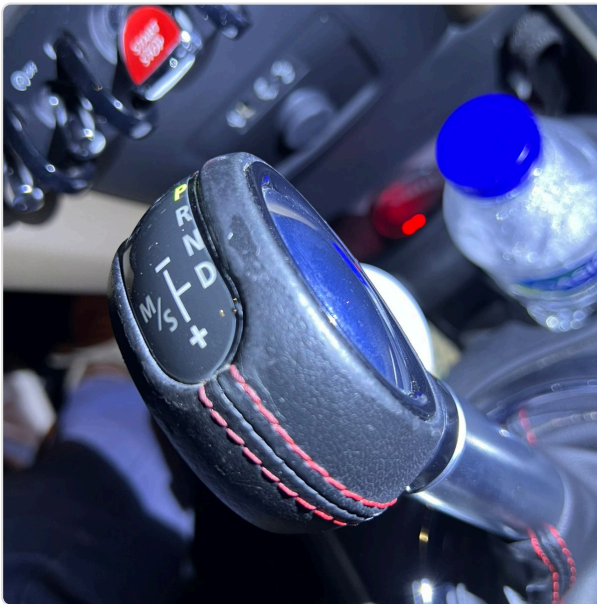
| Gear Lever Photo | |

| Gear Lever | Minor scratches |

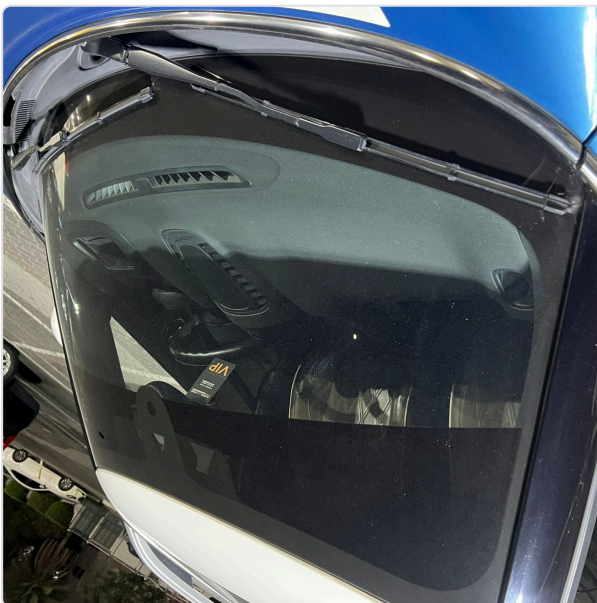
Wipers Photo

Front wipers bleed needs to be replaced
